Acquisition Considerations of the  
**Virginia & Truckee Locomotive #11 *Reno***  
Prepared for the Nevada Board of Museums  
and History  
The Nevada State Railroad Museum  
June 11, 2019

### **Background of the *Reno*:**

Scope of work: #11, boiler

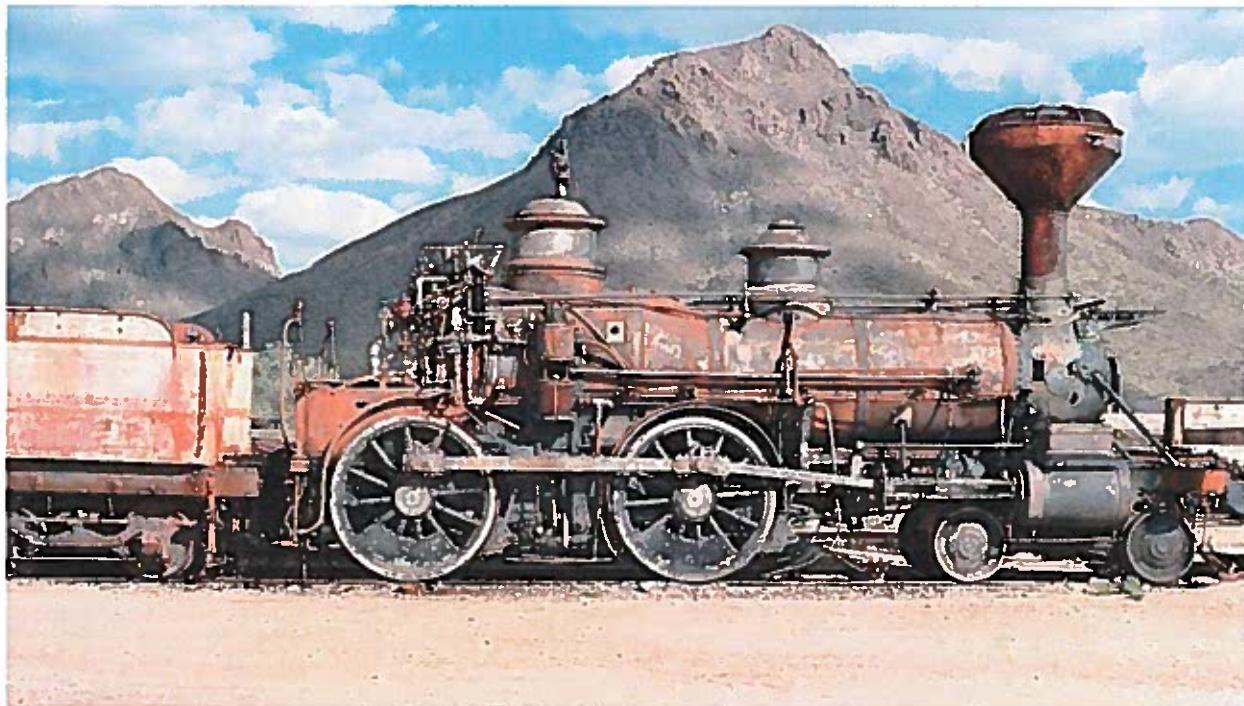
V&T #11 the *Reno* as it appeared in 1995 following the fire

It would be fair to ask why NSRM wouldn't do the same with the *Reno*. Unfortunately, the *Reno* was engulfed in flame during a fire at Old Tucson in 1995. All the organic material on the locomotive and tender was destroyed. This includes the wood cab, the wood frame of the tender and tender trucks. The wool waste in the journal boxes was also destroyed. Some inorganic fabric was lost as well, such as the glass and soft metal appointments. All the original paint waiting to be discovered by physical researchers was destroyed. What remains is the heavy iron of the frame, boiler, and wheels.

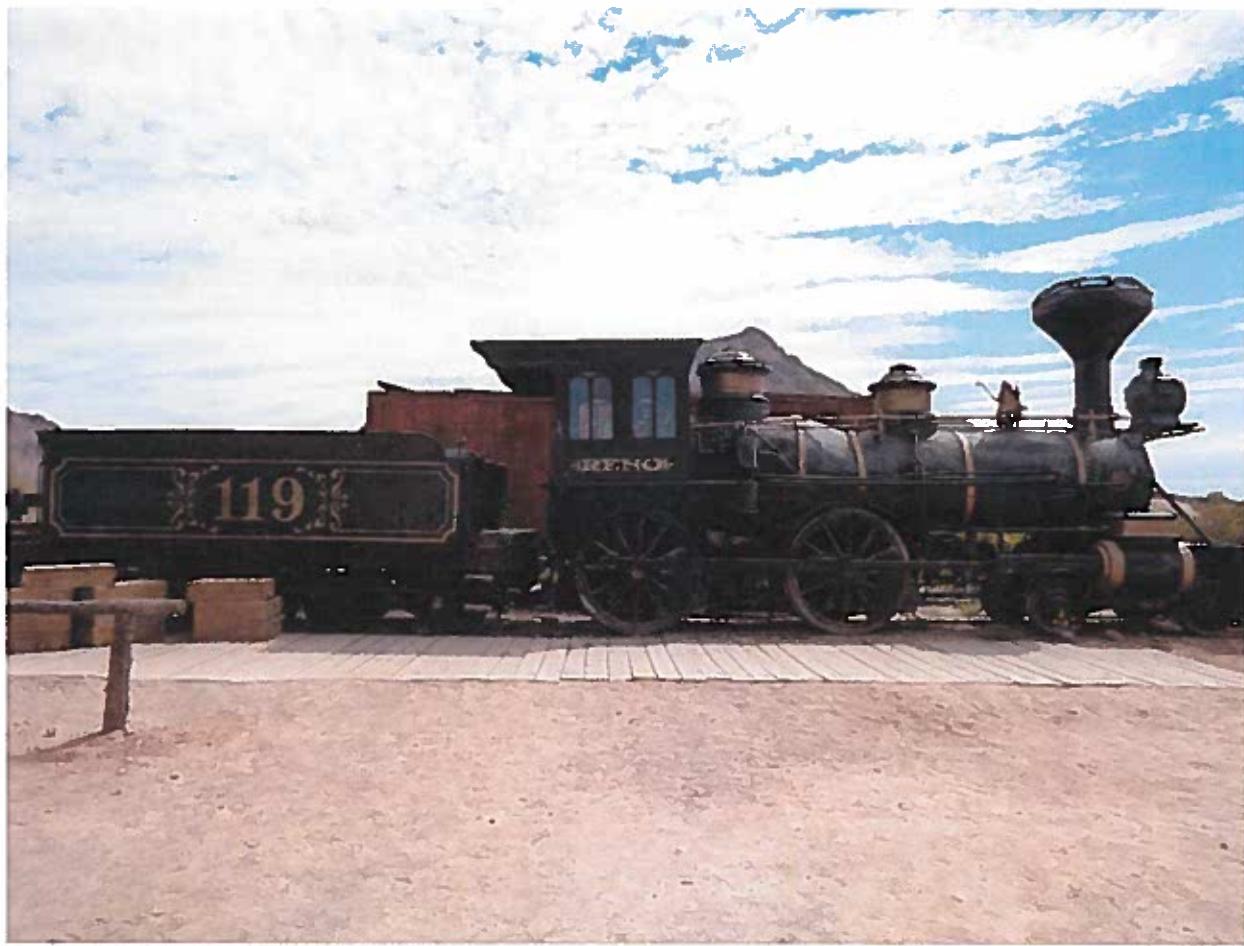
Locomotive #11 as it appears in 2014, photo by and used with the permission of Taylor McCready

The *Reno*, is in “rough restorable” condition. The locomotive will require extensive labor and monies to return to a presentable and functioning state. The work would be on par with the effort made on the locomotive *Glenbrook*. It is the goal of NSRM to return the locomotive to operation with the intention to use it in the interpretative program of operating trains at NSRM.
